## **NCHSE's Engagement with Water Harvesting Initiative**

### **Watershed Management in Kudi village of Madhya Pradesh: A case study**

#### **Post Project Assessment:**

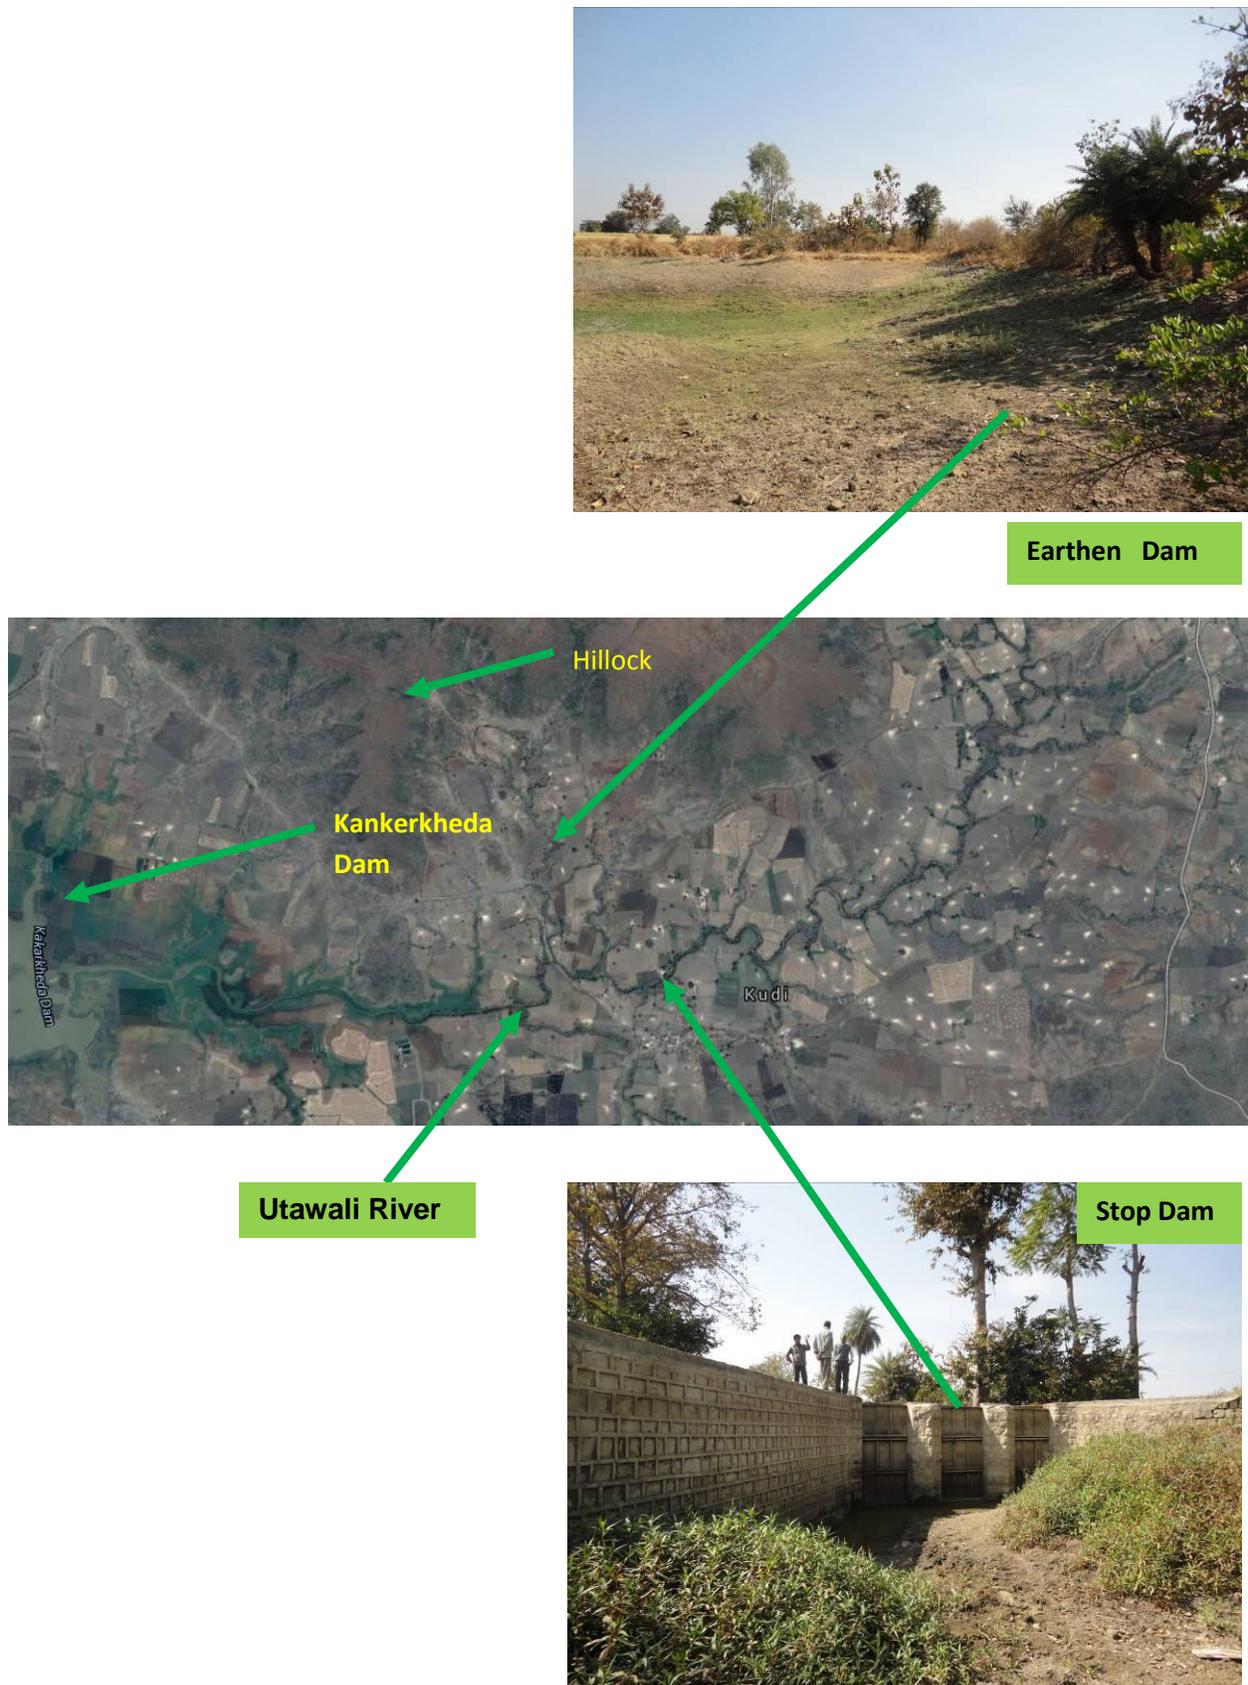
Fig. 1. Development activities in the Utawali River catchment

The Kudi micro watershed with total area of 687.60 ha falls under Kankerkheda Panchayat and drained by Utawali River, which originates on the highlands on the North–East of Kudi village. The Utawali River has been dammed at Kankerkheda village on the downstream of Kudi village (Fig 1). Consequently, the Kudi Village and its crop lands falls under non command area.

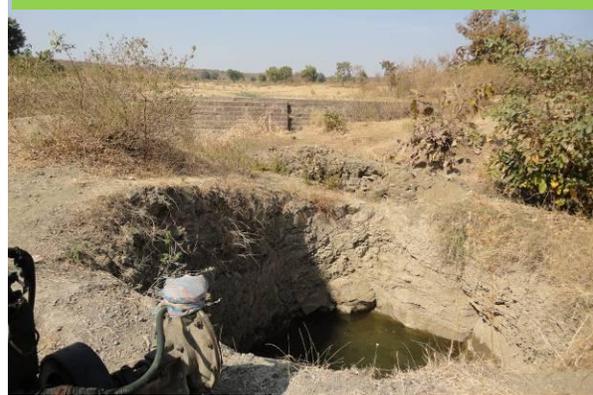
iv. The check dams are also serving its purpose as a surface water resource for short period after monsoon. However, its relevance in facilitating ground water recharge is quite evident as there are water at a depth of about 3m from ground level in the dug wells constructed just downstream of the check dam.

**Dug well down stream of Check Dam**

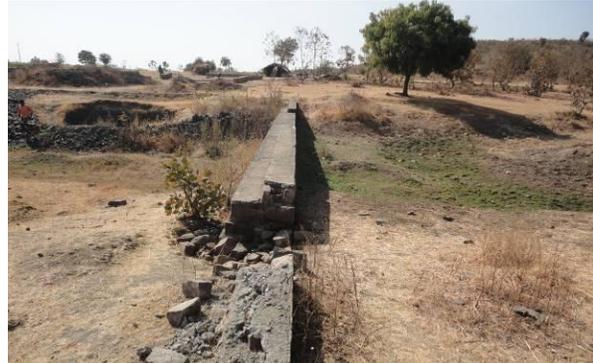
v. Sections of the masonry structure near the abutment of some of the stop/check dams have been damaged, which needs repair at the earliest to get the benefit for a longer period.

**Damaged Check dam**

vii. Due to financial constraints, farmers could not take up repair of Stop/check dams and desilting of river bed or the earthen dams. At present only the operation of the stop dams are being looked after by some enlightened farmers for the collective benefit. There is willingness among the farmers for regular maintenance of the water harvesting structures. They also expressed desire for technical support for improving agricultural production.
