## **Pasture land development through water conservation and bio-physical method of protection- A case study.**

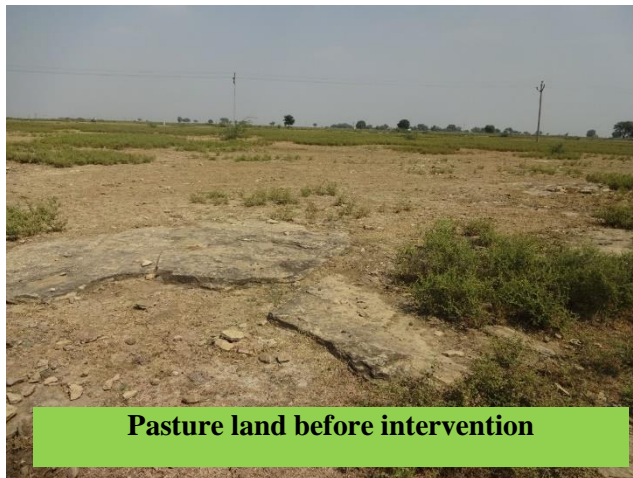
**Pasture land before intervention**

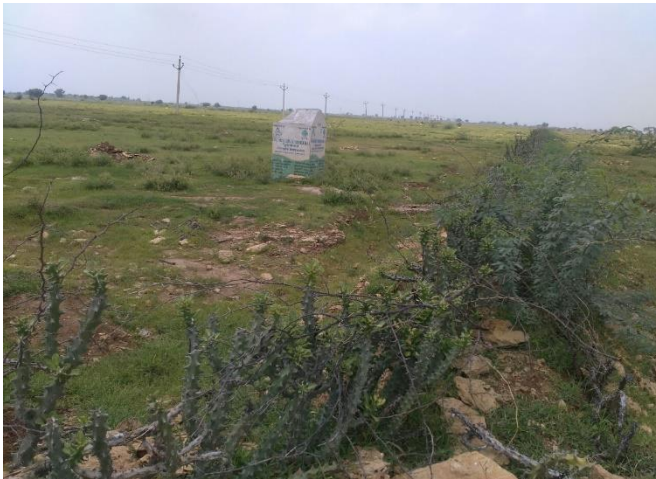
**Cactus plantation along courtour trench as bio physical barrier for protection of Pasture land**

During 2016-17, works of development of the pasture land- Cattle Protection Trench (CPT) demarcating the wasteland was dug, cactus transported from Jhalawar was planted along the ridge of the CPT and grass seeds were sown for fodder.
